## **BID ADDENDUM #1**

### Cafeteria Walk-Ins Replacement Project Project 23-414 California State University Stanislaus One University Circle, Turlock, CA 95382

## Asbestos & Lead Survey Report

Walk-In Freezer Replacement California State University, Stanislaus Cafeteria One University Circle Turlock, CA 95382

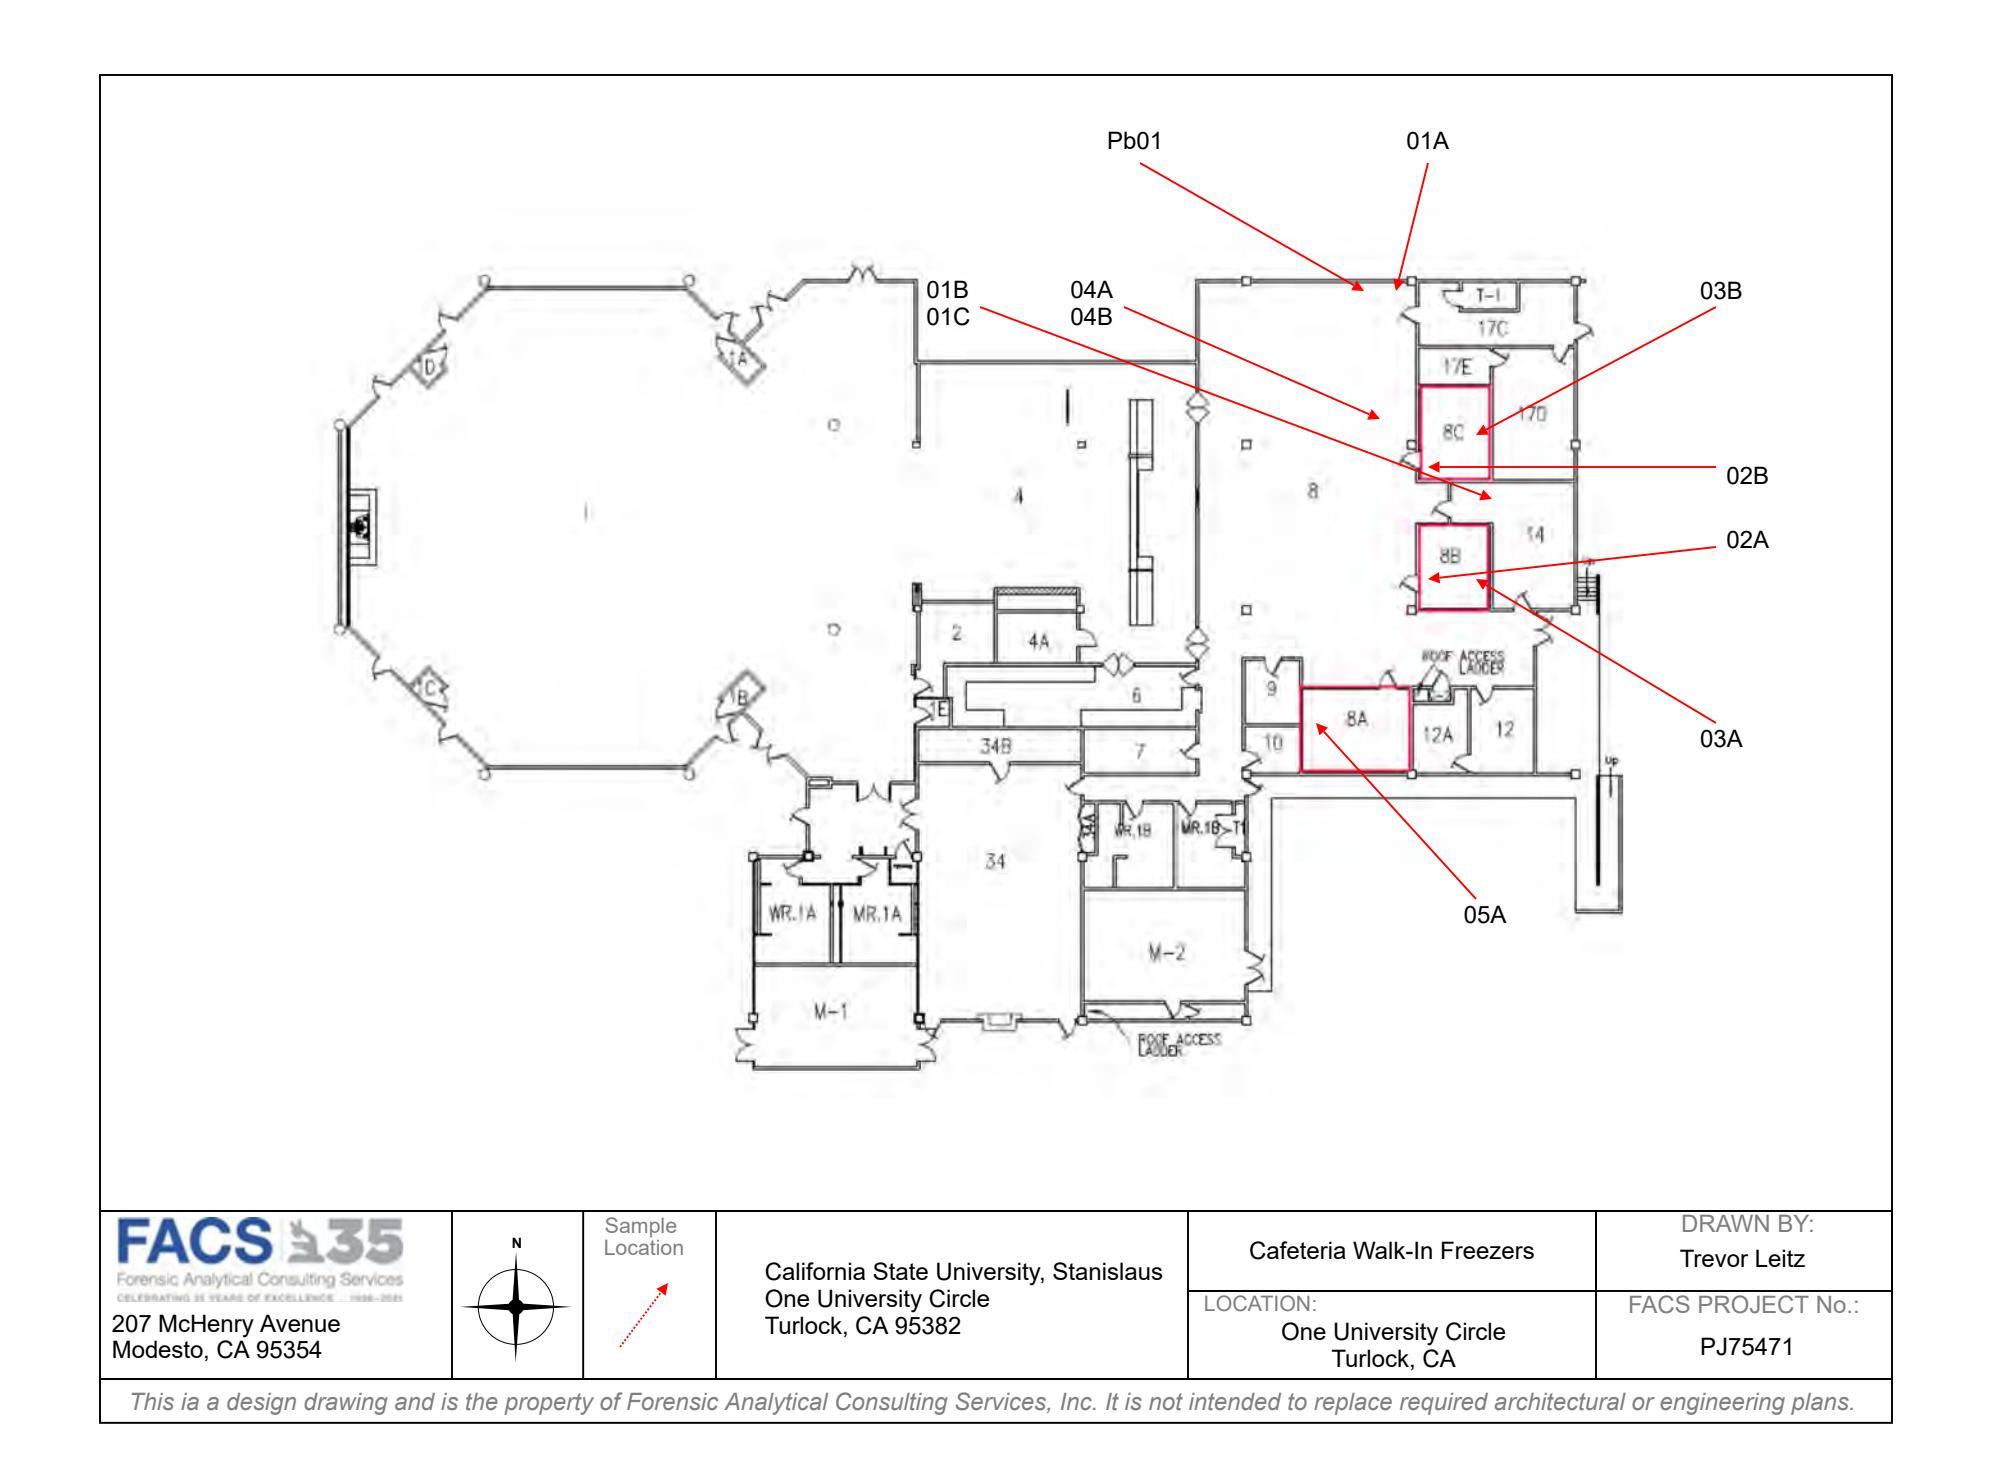
### Appendix C Sample Location Drawing

Asbestos Survey Summary (Lab Report #B345279) CSUS – Cafeteria – Walk-In Freezer Replacement Survey Date: March 14, 2023									
Sample Number	Material Description	Location(s) of Material	Material Number	Asbestos Content (%)	Asbestos NESHAP Category	Approximate Quantity (ft <sup>2</sup> )				
01A-01C	Drywall – Orange Peel Texture	Kitchen Kitchen Storage	01	Layer: White Drywall: ND Layer: Off-White Skimcoat/Joint Compound: 2% Chrysotile Layer: Paint: ND	RACM	1,000 ft <sup>2</sup>				
02A-02B	Epoxy – Tan Specks	Freezer 8A-8C	02	Layer: Tan Cementitious Material: ND Layer: Grey Cementitious Material: ND	NA	NA				
03A-03B	Freezer Sealant – Grey	Freezer 8B & 8C	03	Layer: Grey Putty: 5% Chrysotile	Category II Non-Friable	10 LF				
04A-04B	2x4 FCP – Smooth	Kitchen	04	Layer: White Drywall: ND Layer: Paint: ND	NA	NA				
05A	Freezer Gasket	Freezer 8A	05	Layer: Grey Non-Fibrous Material: ND	NA	NA

Lead Paint Chip Summary (Lab Report #M249290) CSUS – Cafeteria – Walk-In Freezer Replacement Survey Date: March 14, 2023							
Sample Number	Component Location	Component	Color	Substrate	Analytical Results (weight percent of lead)			
01Pb	Kitchen – NE Corner	Wall	White	Drywall	< 0.006
